Earthquake-Induced Ground Fissuring in Foot-Slope Positions of the Port Hills, Christchurch

A thesis

Master of Science in Engineering Geology

University of Canterbury

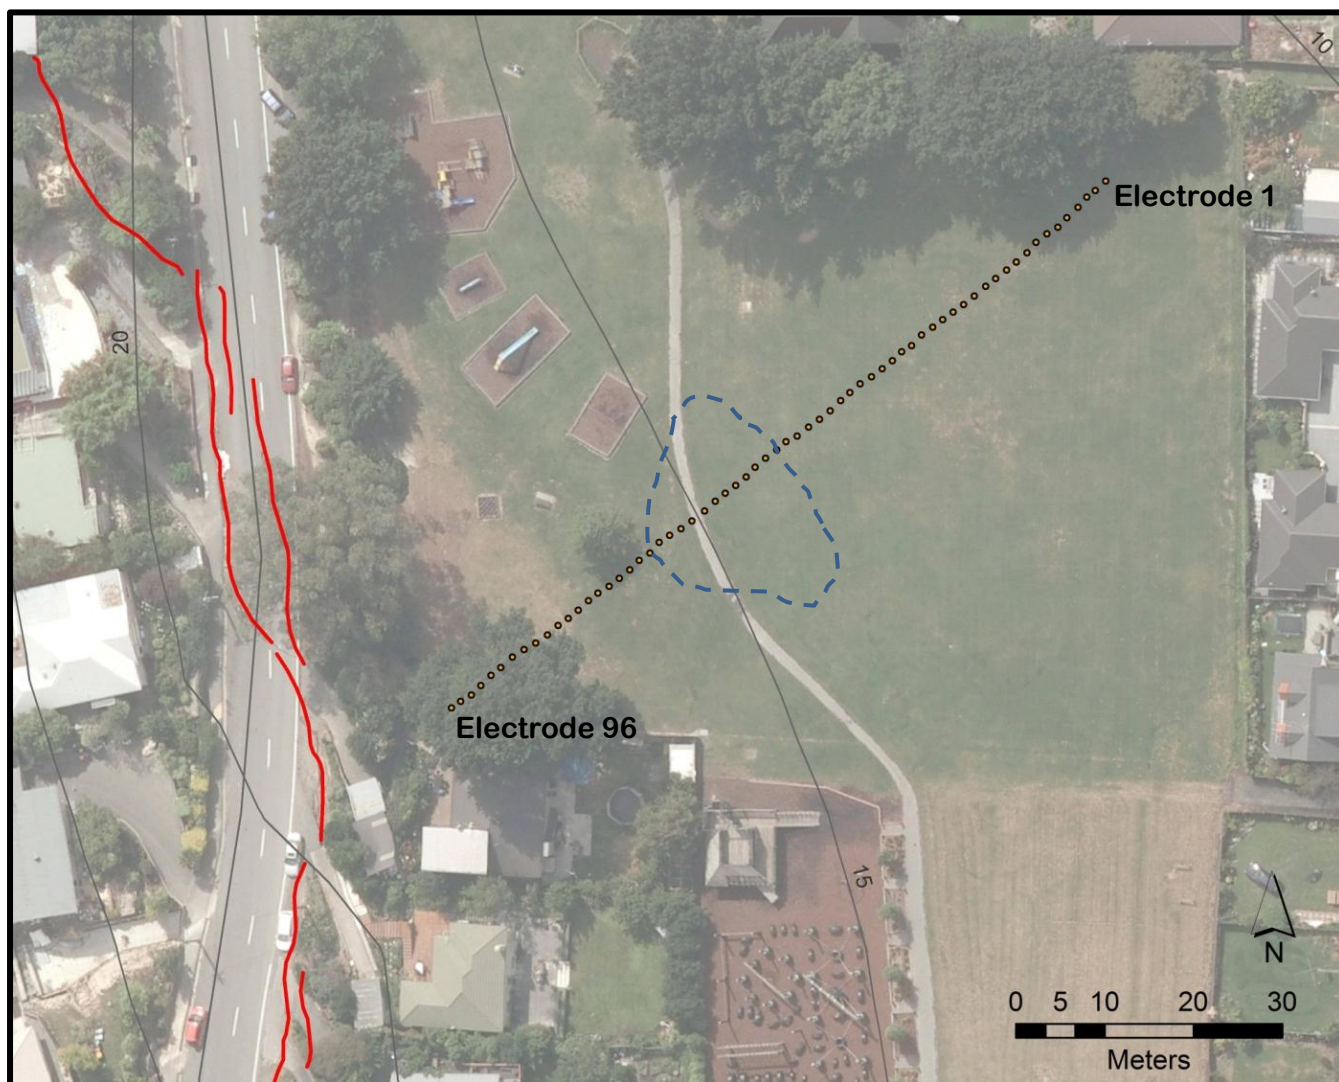
The resistivity survey was conducted in July 2012 at Centaurus Park. The maximum line length possible was 96 m due to the presence of houses and paved roadways in the area, and it was not possible to pass the survey directly across the Ramahana Road fissures. It was decided to align the survey approximately perpendicular to the fissure trace, thus running on a diagonal through the park (this also enabled greater use of the available space). The weather in previous days had been wet, and on the day of the survey there was occasional light rain, meaning the topsoil was saturated and ideal for conducting electricity. An area of boggy ground was noted near the centre of the survey, extending between electrodes 33 and 45 (Figure 4.35).

Figure 4.35 Centaurus Park resistivity survey electrode placing with upper right end being the start of the line. Red lines are mapped fissure traces crossing Ramahana Road. Area defined by dashed blue line shows location of boggy ground. Thin grey lines show five metre contours of elevation above sea level.

The zone of high resistivity in the centre of the model does not correspond with the location of the concrete path which crosses the survey site (Figure 4.35), but rather falls to the north-west of the path, coinciding with the area of boggy ground. It was expected that this area would have a low resistivity value, making this an unusual outcome. There is, however, an area of low resistivity 1-2 m below the surface in the centre of the section, which does satisfactorily coincide with the water-logged area.

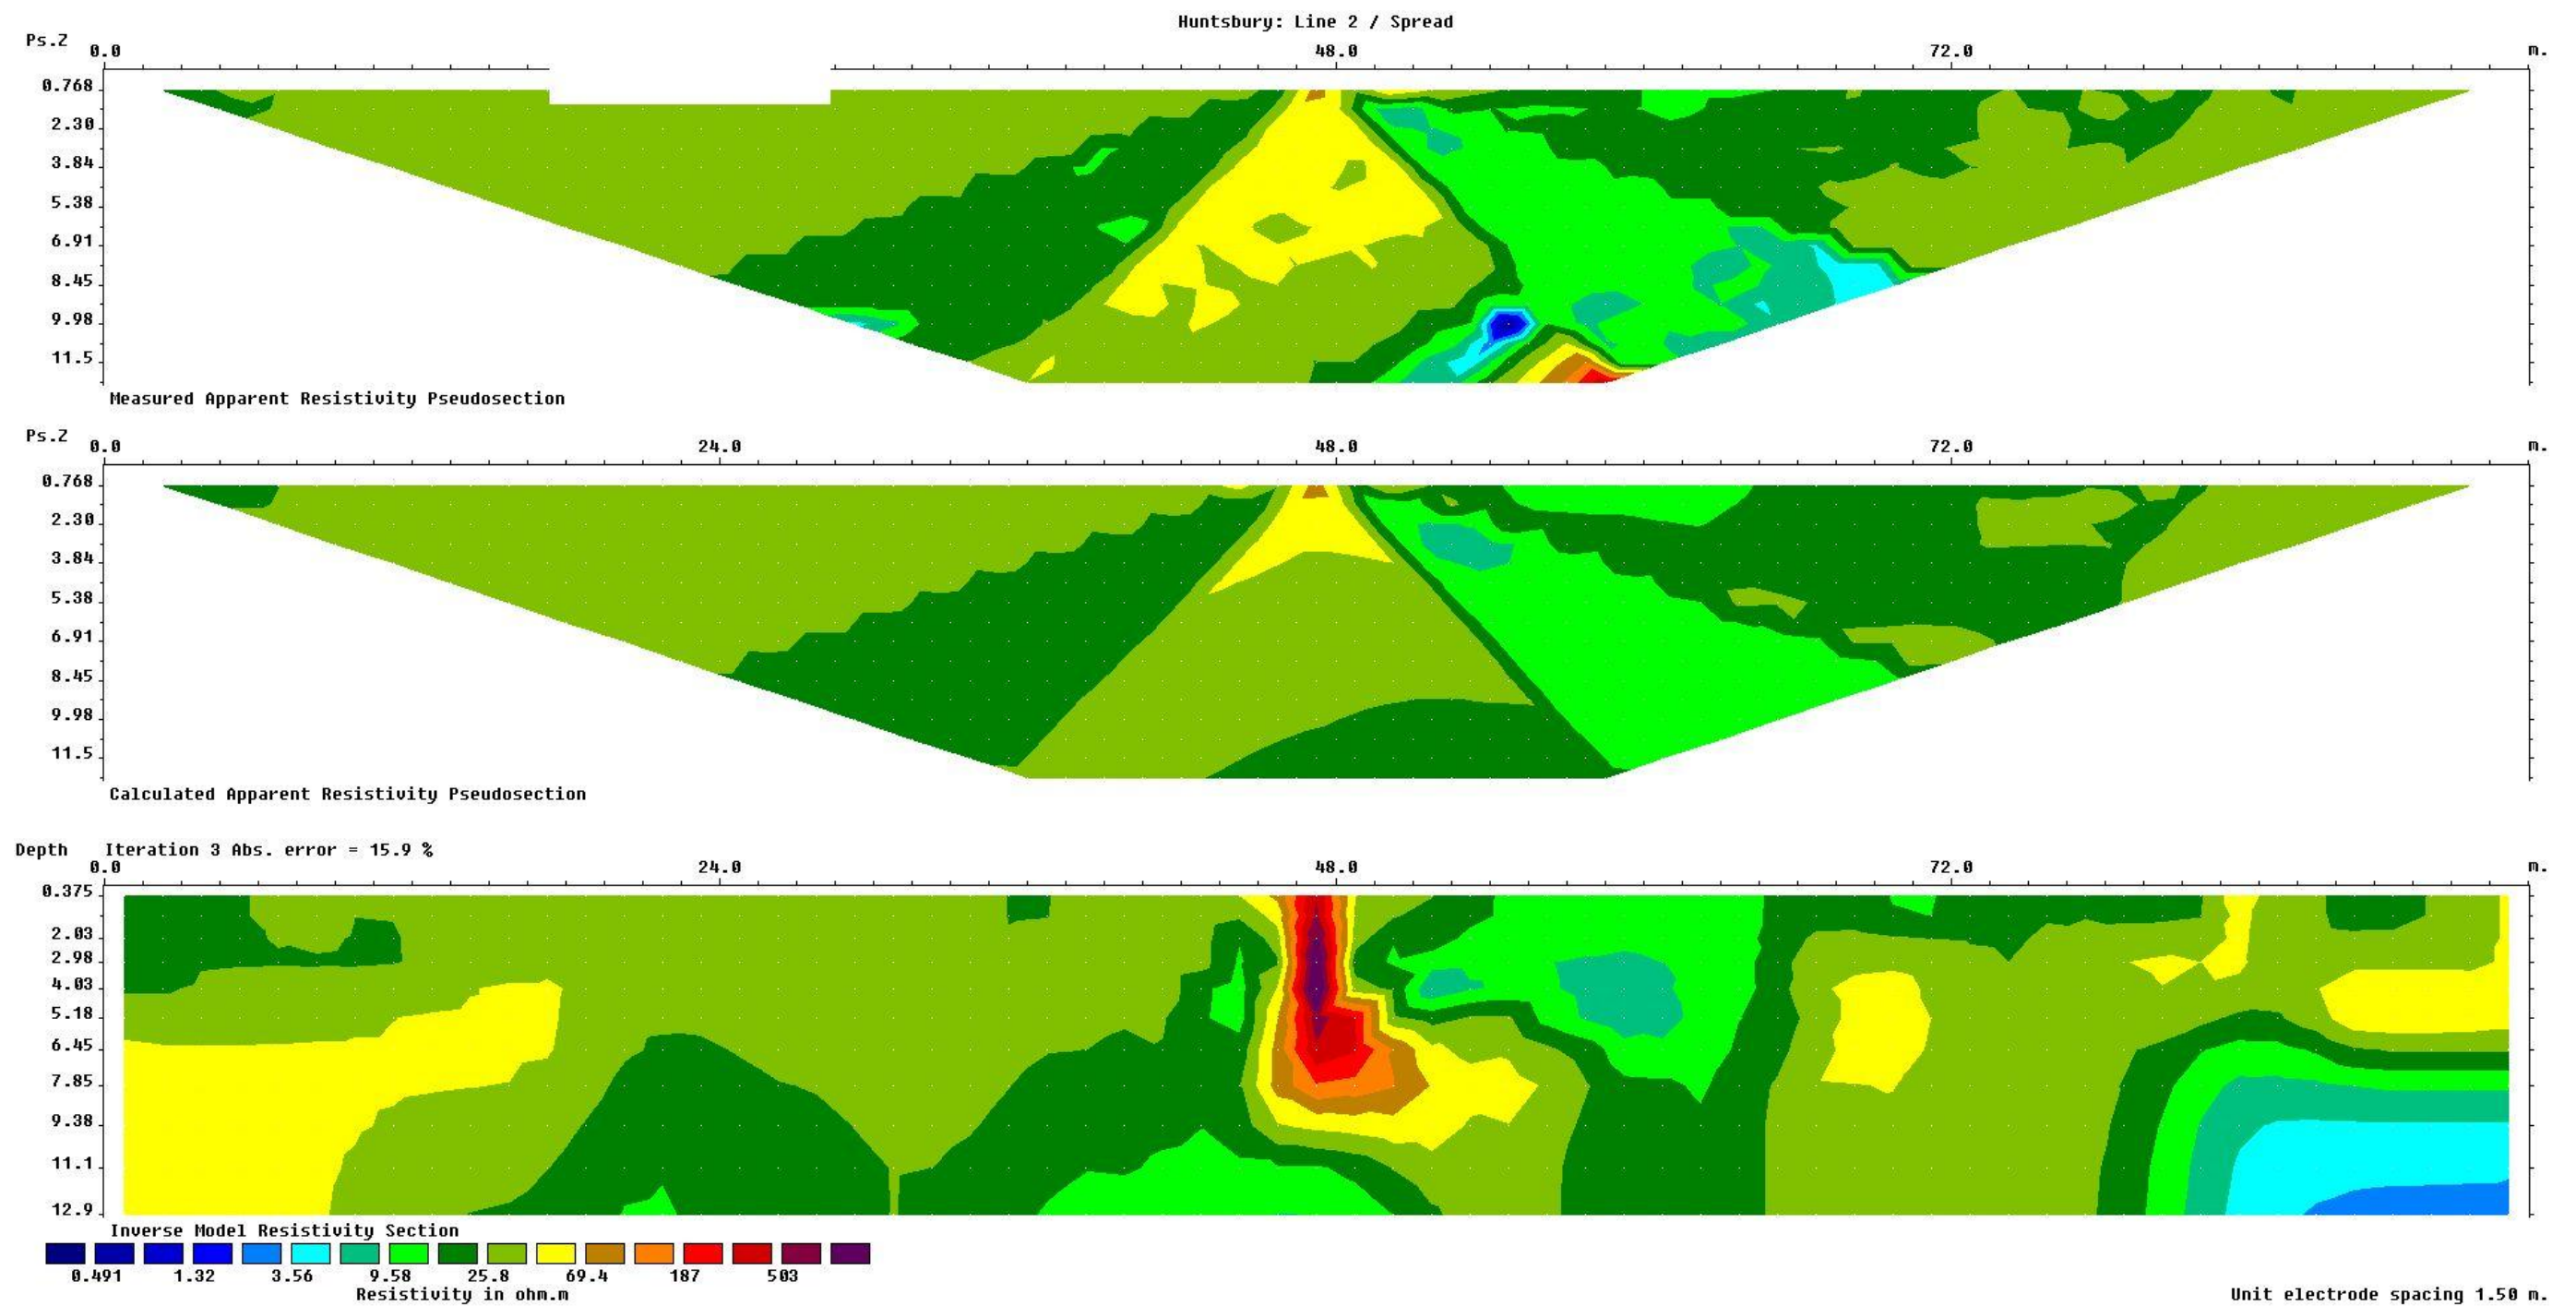
The central zone of high resistivity trends towards the south-west. This may coincide with the subsurface geology, perhaps indicating a band of colluvial material within the clayey-loess. This area may also correspond to subsurface compression features related to the fissuring above, although it is unknown how this movement may affect the resistivity values of a soil. The section of low resistivity at the bottom of the cross-section is likely indicative of higher ground water levels. This is consistent with the appearance of springs in the area (see Section 4.7), indicating the presence of a high water table.

Figure 4.36 First processing of resistivity outputs showing inversion approximation based on least squares inversion.

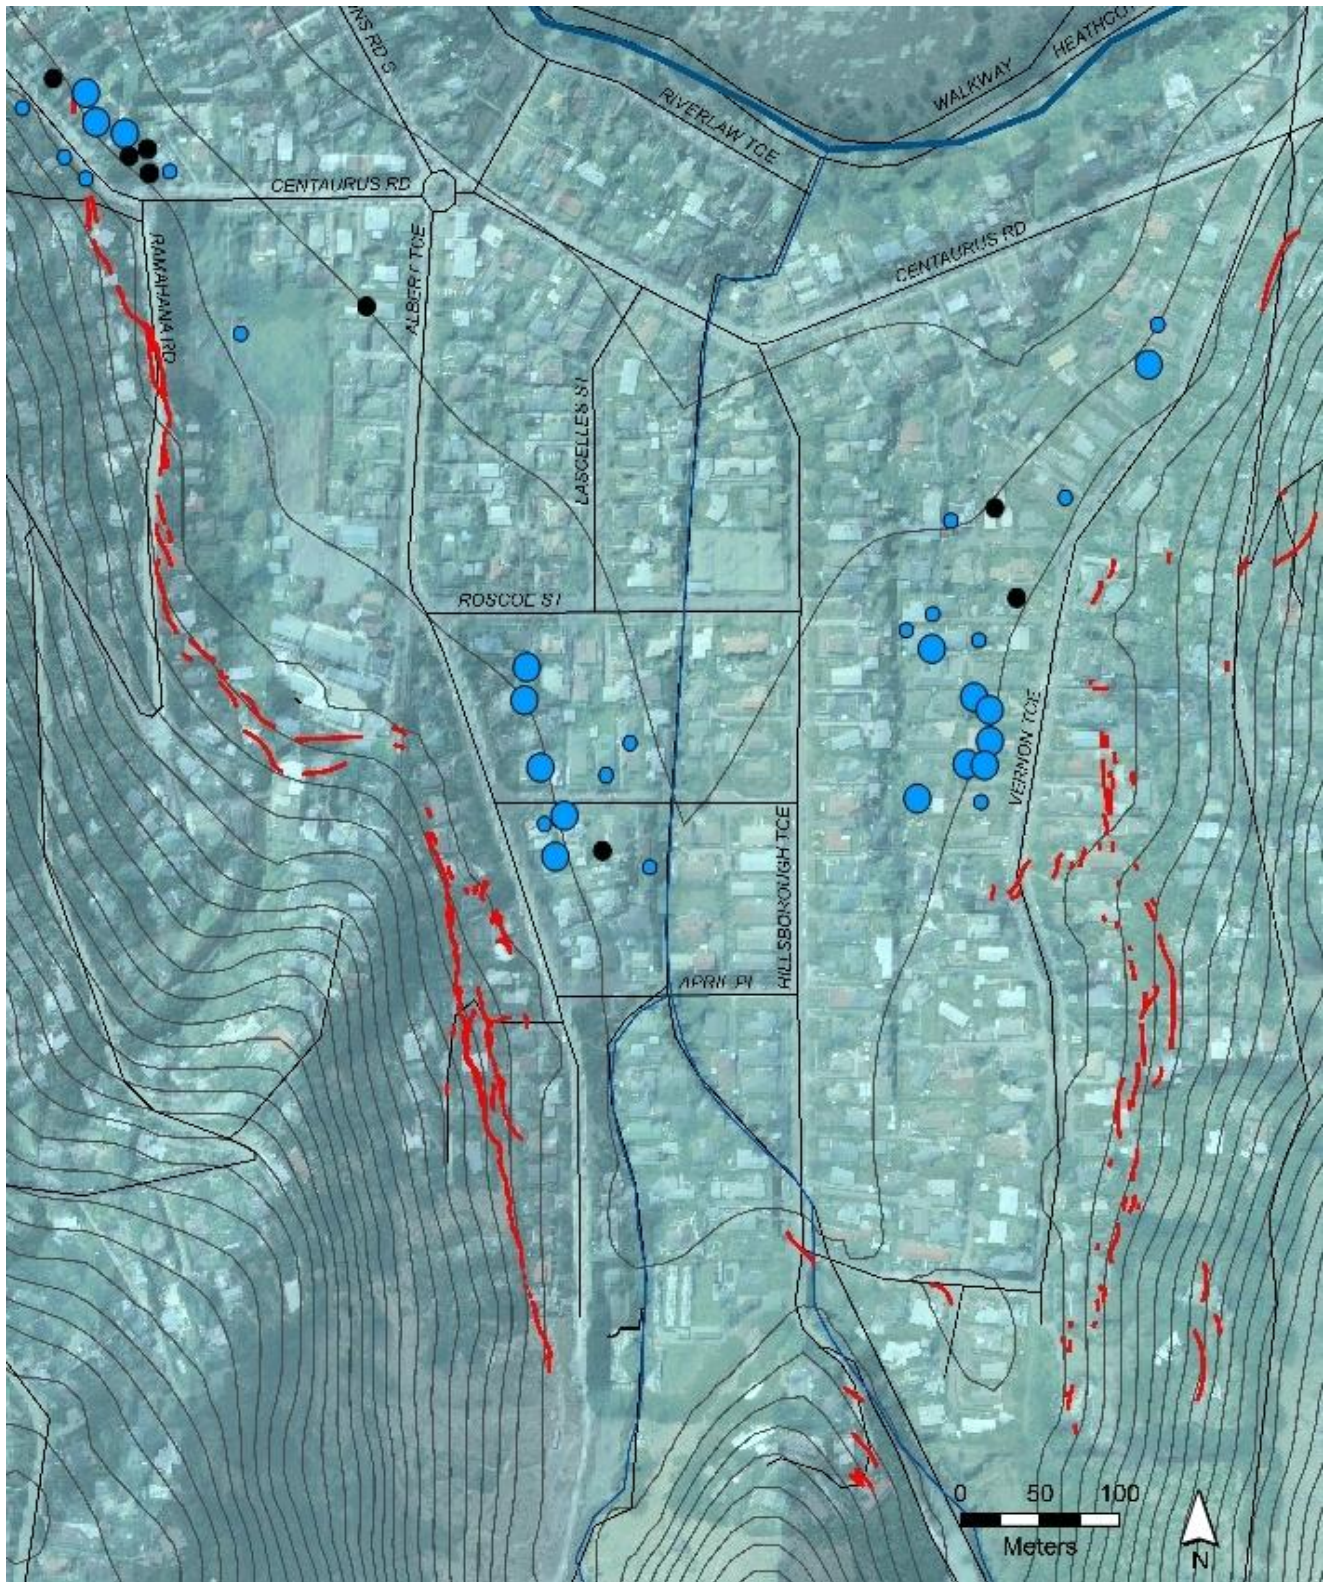
The springs are located in three main groups; one at the end of the western fissure, where Ramahana Road meets Centaurus Road; another along the eastern side of Albert Terrace, about half-way into the valley by Leonard Place; and the third about half-way down Vernon Terrace, on the western side of the road. Figure 4.40 provides a summary of the location and extent of the ground water problems in the Hillsborough Valley area.

Figure 4.40 Map of known locations of springs, seepage and/or ponding issues in the Hillsborough Terrace valley area. Large blue dots show sites of flowing springs, small blue dots are areas of persistent seepage or boggy ground, and black dots show sites where ground water issues were reported but the extent is unknown by the author. Red lines indicate the fissure trace. Spring data from H. Rutter (Aqualinc, 2012) and the author's own observations.

From studies of the map produced in Figure 4.40, it is apparent that the springs are located towards the northern end of each distinct section of fissure trace. The Vernon Terrace springs occur at the end of the section of hillside with the most fissuring, although some fissuring does continue further north, perhaps being the cause for the spring behaviour at 8 and 10 Vernon Terrace. On the western side there are two groups of springs, the one on Albert Terrace occurs at the “dog-leg” in the fissure zone, and the one on Centaurus Road occurs at the far end of the fissuring, and actually coincides with the fissure trace in 211 Centaurus Road. This layout indicates that there is a correlation between the locations of the springs and the locations of the fissures. It is uncertain whether one caused the other, or whether they are both outcomes of a higher-level, as yet undefined, geotechnical occurrence.

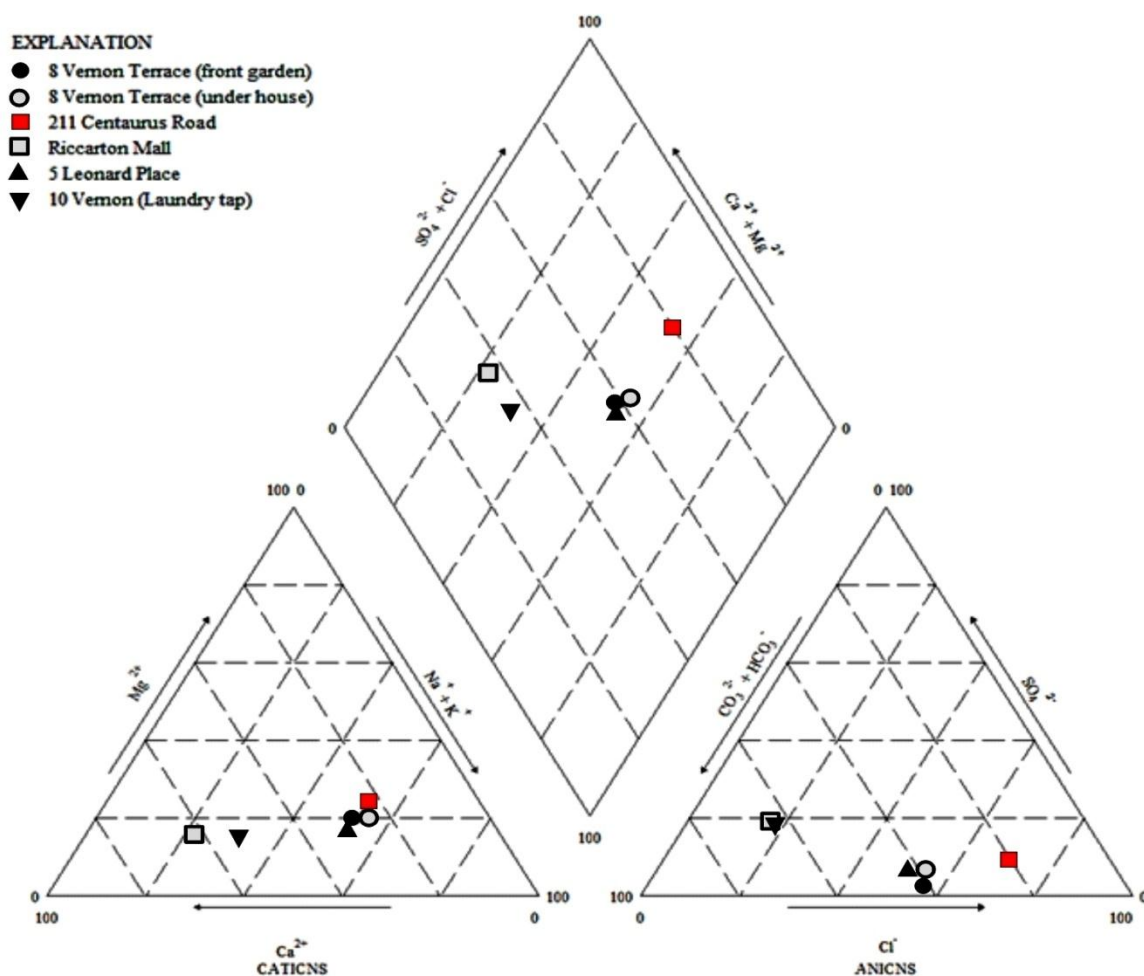
Water collected from springs in the Hillsborough Valley has been analysed Aqualinc Research Ltd, who have been investigating the changes to groundwater in the Hillsborough Valley area following the earthquakes. Piper plots of the chemical constituents of the water (Figure 4.42) has shown that water from the Vernon Terrace, Centaurus Road and Leonard Place springs has a mineral content consistent with that typical of water which has been sourced from within the volcanic rocks of the Port Hills. This water was compared to water collected from Riccarton Mall, and from a laundry tap at 10 Vernon Terrace, both of which were sourced from

Figure 4.42 Piper plots of chemical analysis of spring water from Vernon Terrace, Centaurus Road and Leonard Place, showing significantly different chemical composition to water sourced from Canterbury Plains aquifers collected at Riccarton Mall and from a tap at 10 Vernon Terrace. After H. Rutter, Aqualinc Research Ltd, pers. comm. 2012).

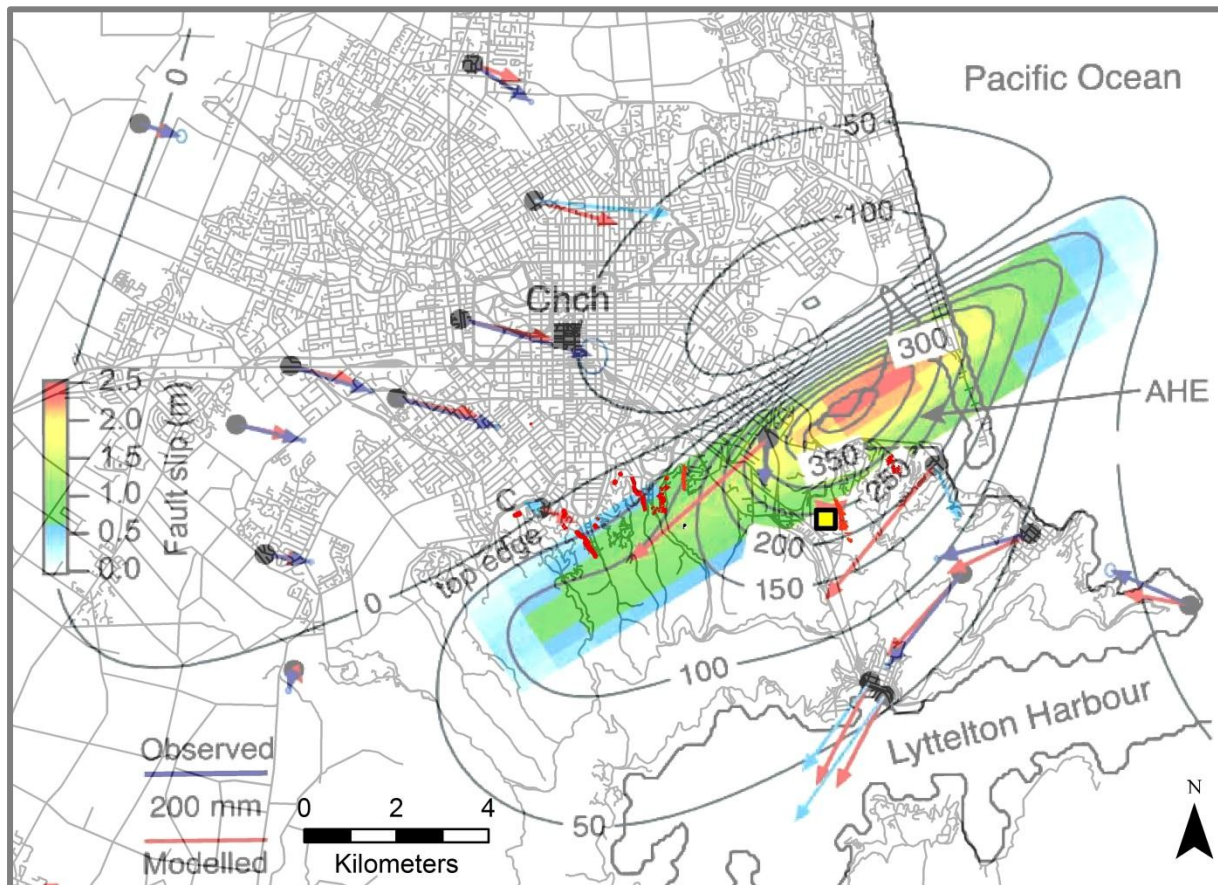
Two main models of the location of the fault responsible for the Christchurch Earthquake have been postulated to date. These are summarised as a single-fault model, as proposed by both Kaiser et al. (2012) and Beaven et al. (2011), and as a two-fault model, as proposed by Eliot et al. (2012) and Beavan et al. (2011) whereby the fault branches at around the Hillsborough Valley area, with one segment trending north north-east, and the other continuing straight. Figure 5.3 overlays a map of the modelled fault location and slip magnitude, as published by Kaiser et al. (2012), above a street map of Christchurch, and the fissure traces as mapped by the author. The resultant image shows that the top edge of the fault, albeit at a depth of approximately one kilometre, visibly coincides with the locations of Category A fissures (that is, those of Bowenvale Valley, Hillsborough Valley and the Huntlywood Terrace area) which are aligned directly above the top edge of the fault plane. Figure 5.4 provides a more detailed view of the Hillsborough Valley area, relating the modelled fault positioning from Kaiser et al. with the fissuring in this area, as well as the location of the Hillsborough Reservoir and the springs and compression features. In this image it is particularly clear that the Huntsbury Reservoir and “dog-leg” bend in the Ramahana Road-Albert Terrace fault traces coincide with the location (at depth) of the top edge of the fault plane.

Figure 5.3 Modelled fault location and slip magnitude with overlaid fissure trace locations (red, near centre). The fault is shown dipping to the southeast with its top edge at 1km depth. Filled black circles show the near-field GPS stations contributing to the solution with observed (blue arrows with 95% confidence uncertainty ellipses) and modelled (red arrows) displacements. The yellow and black square shows the epicentre as located using data available in March 2011. The black contours show uplift and subsidence in millimetres as predicted by the model. Overlay fault location of single fault model, after Kaiser et al. 2012.

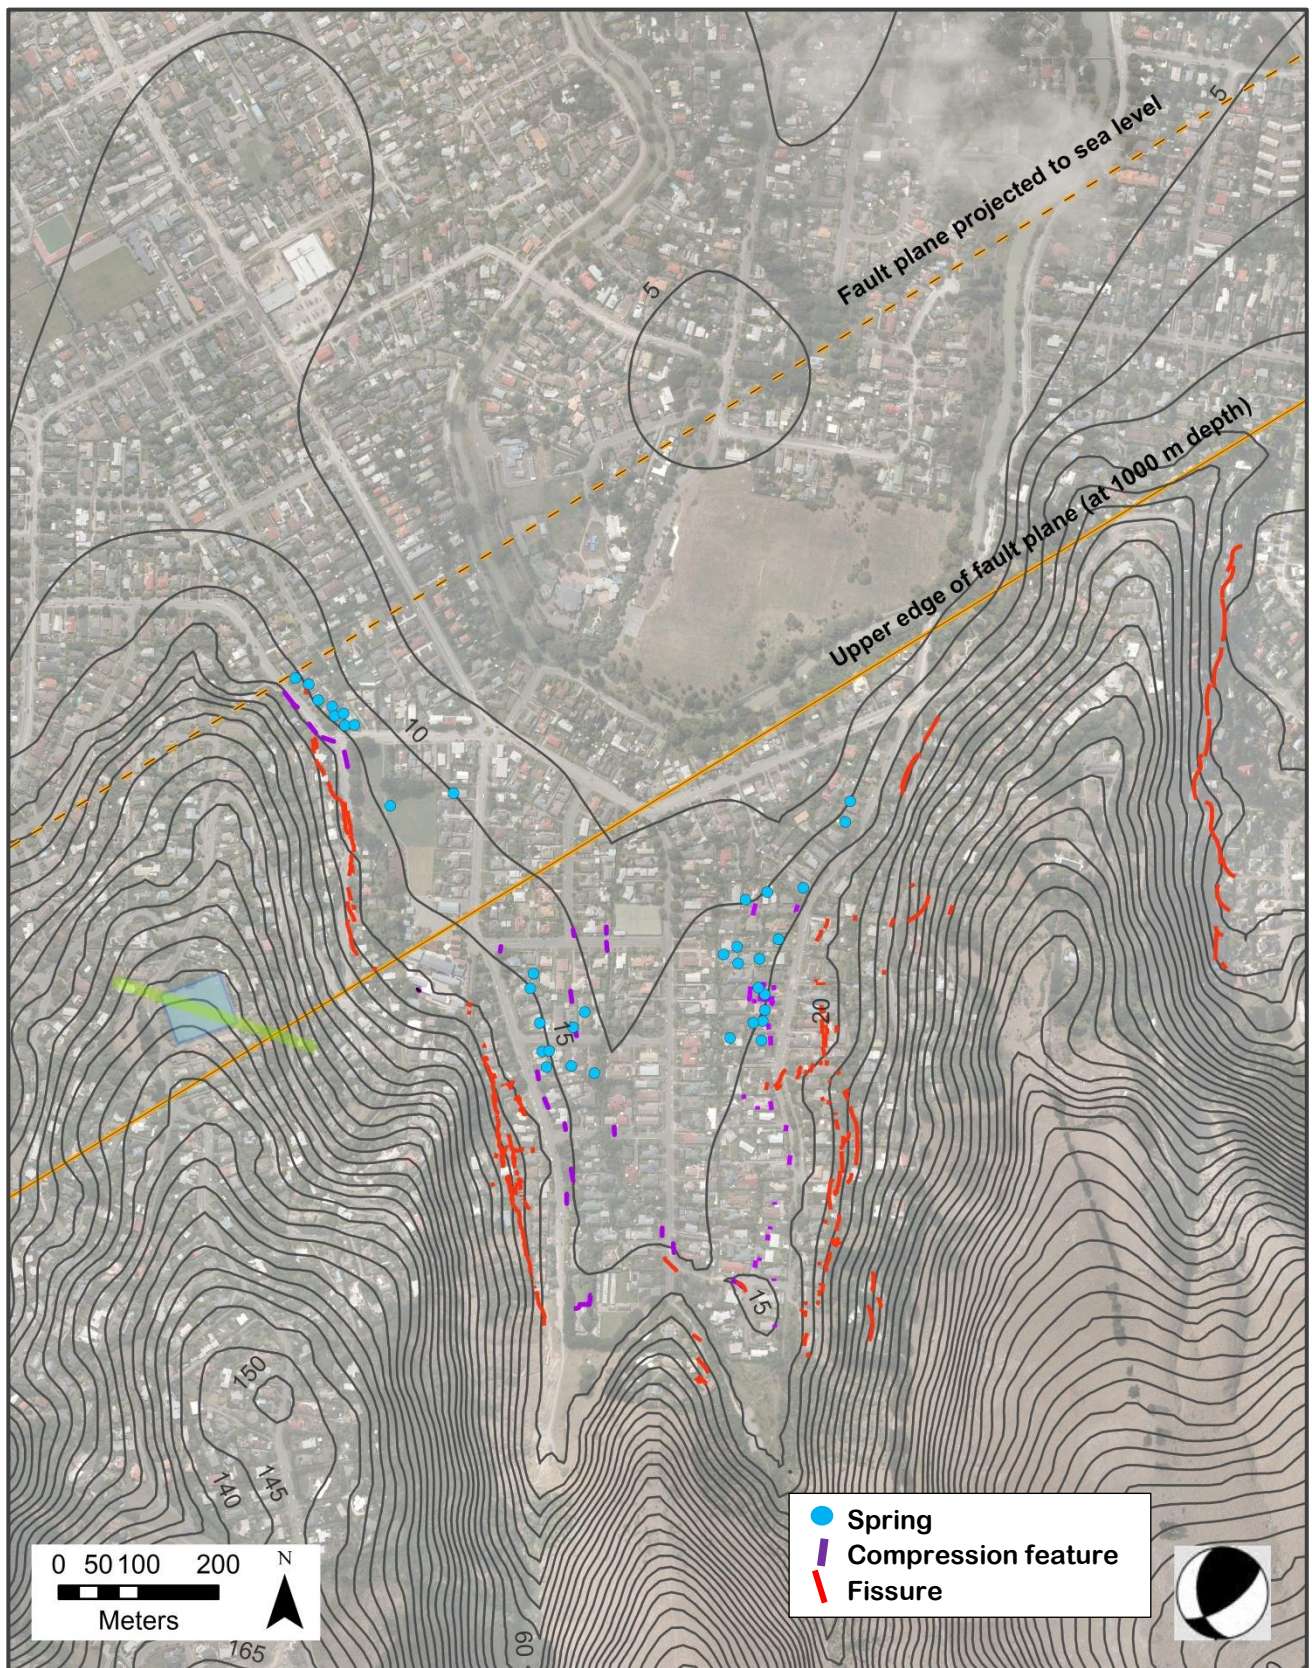
Study of the three dimensional modelling shown in Figure 5.6, together with the “bird’s-eye” view maps in Figures 5.3 – 5.5, strongly suggest that movement of the upper edge of the fault plane, at even 1000 m below the ground surface, may have caused related fracturing propagating to the surface within the Port Hills volcanic bedrock. With areas of the Port Hills increasing in elevation by up to a metre relative to areas of Christchurch City (Beavan et al. 2011), it would seem logical that fracturing may occur within brittle rocks which straddle the boundary between up-thrown and down-thrown land. This hypothesis provides a possible explanation for the occurrence of the springs, as newly-generated fracture sets would provide enduring conduits for groundwater to reach the surface. The formation of the fracture set through the Huntsbury Reservoir and surrounding area provides circumstantial evidence that some bedrock fracturing did occur within the volcanic rocks of the Port Hills, and these fractures certainly provided a conduit for water as the reservoir was drained. Whether they did form as a result of complex fracture sets propagating to the surface from 1000 m deep fault movement is unproven, however certainly warrants further investigation, as part of a separate study.

Figure 5.4 Map showing location of upper edge of fault plane, at a depth of 1000 m, where it passes beneath the Hillsborough Valley area, as well as the location of the projected sea-level expression of the fault. Huntsbury Reservoir outlined with blue square, and green line showing orientation of shearing. Beachball diagram of fault mechanism shown in lower right corner, and fault plotted using data from Kaiser et al. (2012).

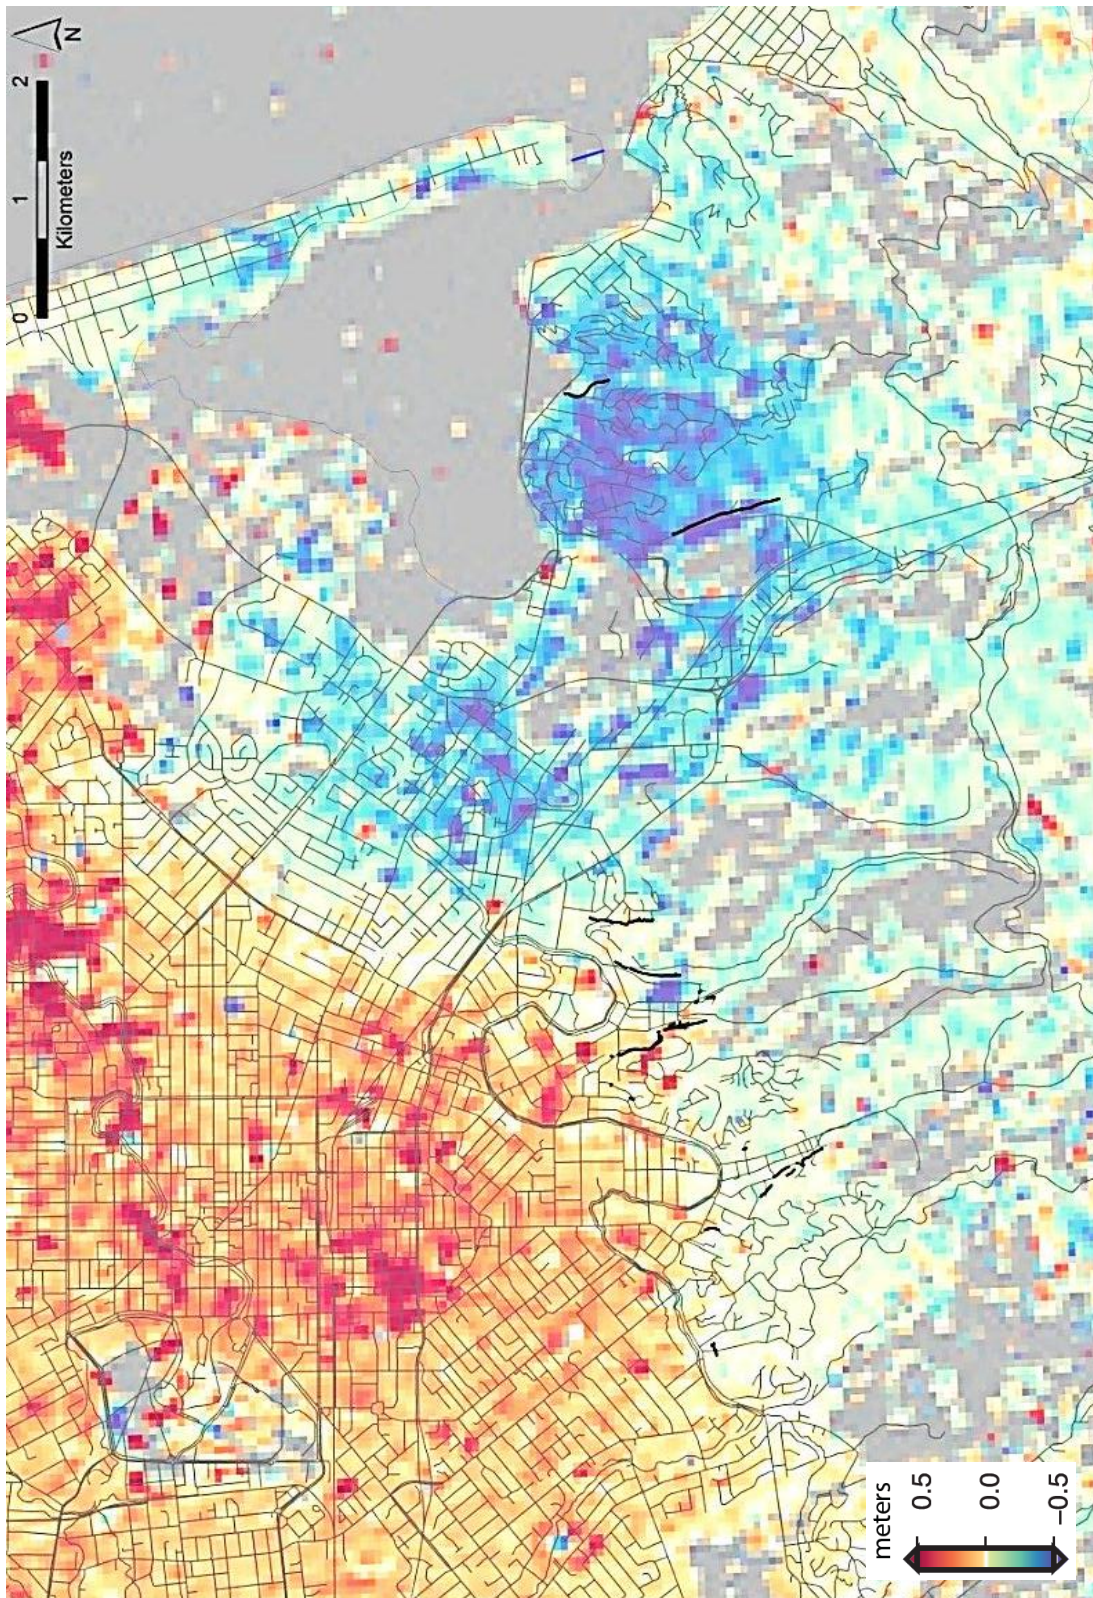
In their 2011 paper, Beaven et al. provided a satellite-produced image of the observed vertical ground displacement. Figure 5.5 shows this image, with fissure traces overlaid by the author. Red areas to the north and west of the Port Hills show areas of vertical displacement away from the satellite, and blue areas in the Port Hills and the Avon-Heathcote Estuary area show areas of vertical displacement towards the satellite. As with Figure 5.3, a correlation is visible between the locations of Category A of fissures, and, in this case, the location

of the boundary between land that largely moved upwards, and land that largely moved downwards. With no gradual colour change between positive and negative vertical displacement, the colour scheme utilised by Beaven et al. (2011) makes it appear as though there were few areas of little or no vertical change. In doing this, however, it does help to delineate the relatively linear, regular boundary between the two displacement directions. This linear boundary prompted Beaven et al.'s proposition of there being two fault traces at angles to each other – one branching off northwards where the linear displacement boundary makes a distinct bend, near the area of Hillsborough Valley (Figure 5.5).

Figure 5.5 Fissure traces (black) and Christchurch road centrelines overlaid with observed ground displacement, with red denoting displacement away from the satellite, and blue denoting movement towards the satellite. Note the distinct boundary between areas of upwards and downwards directed displacement, which coincides with Category A fissures. After Beavan et al. (2011).

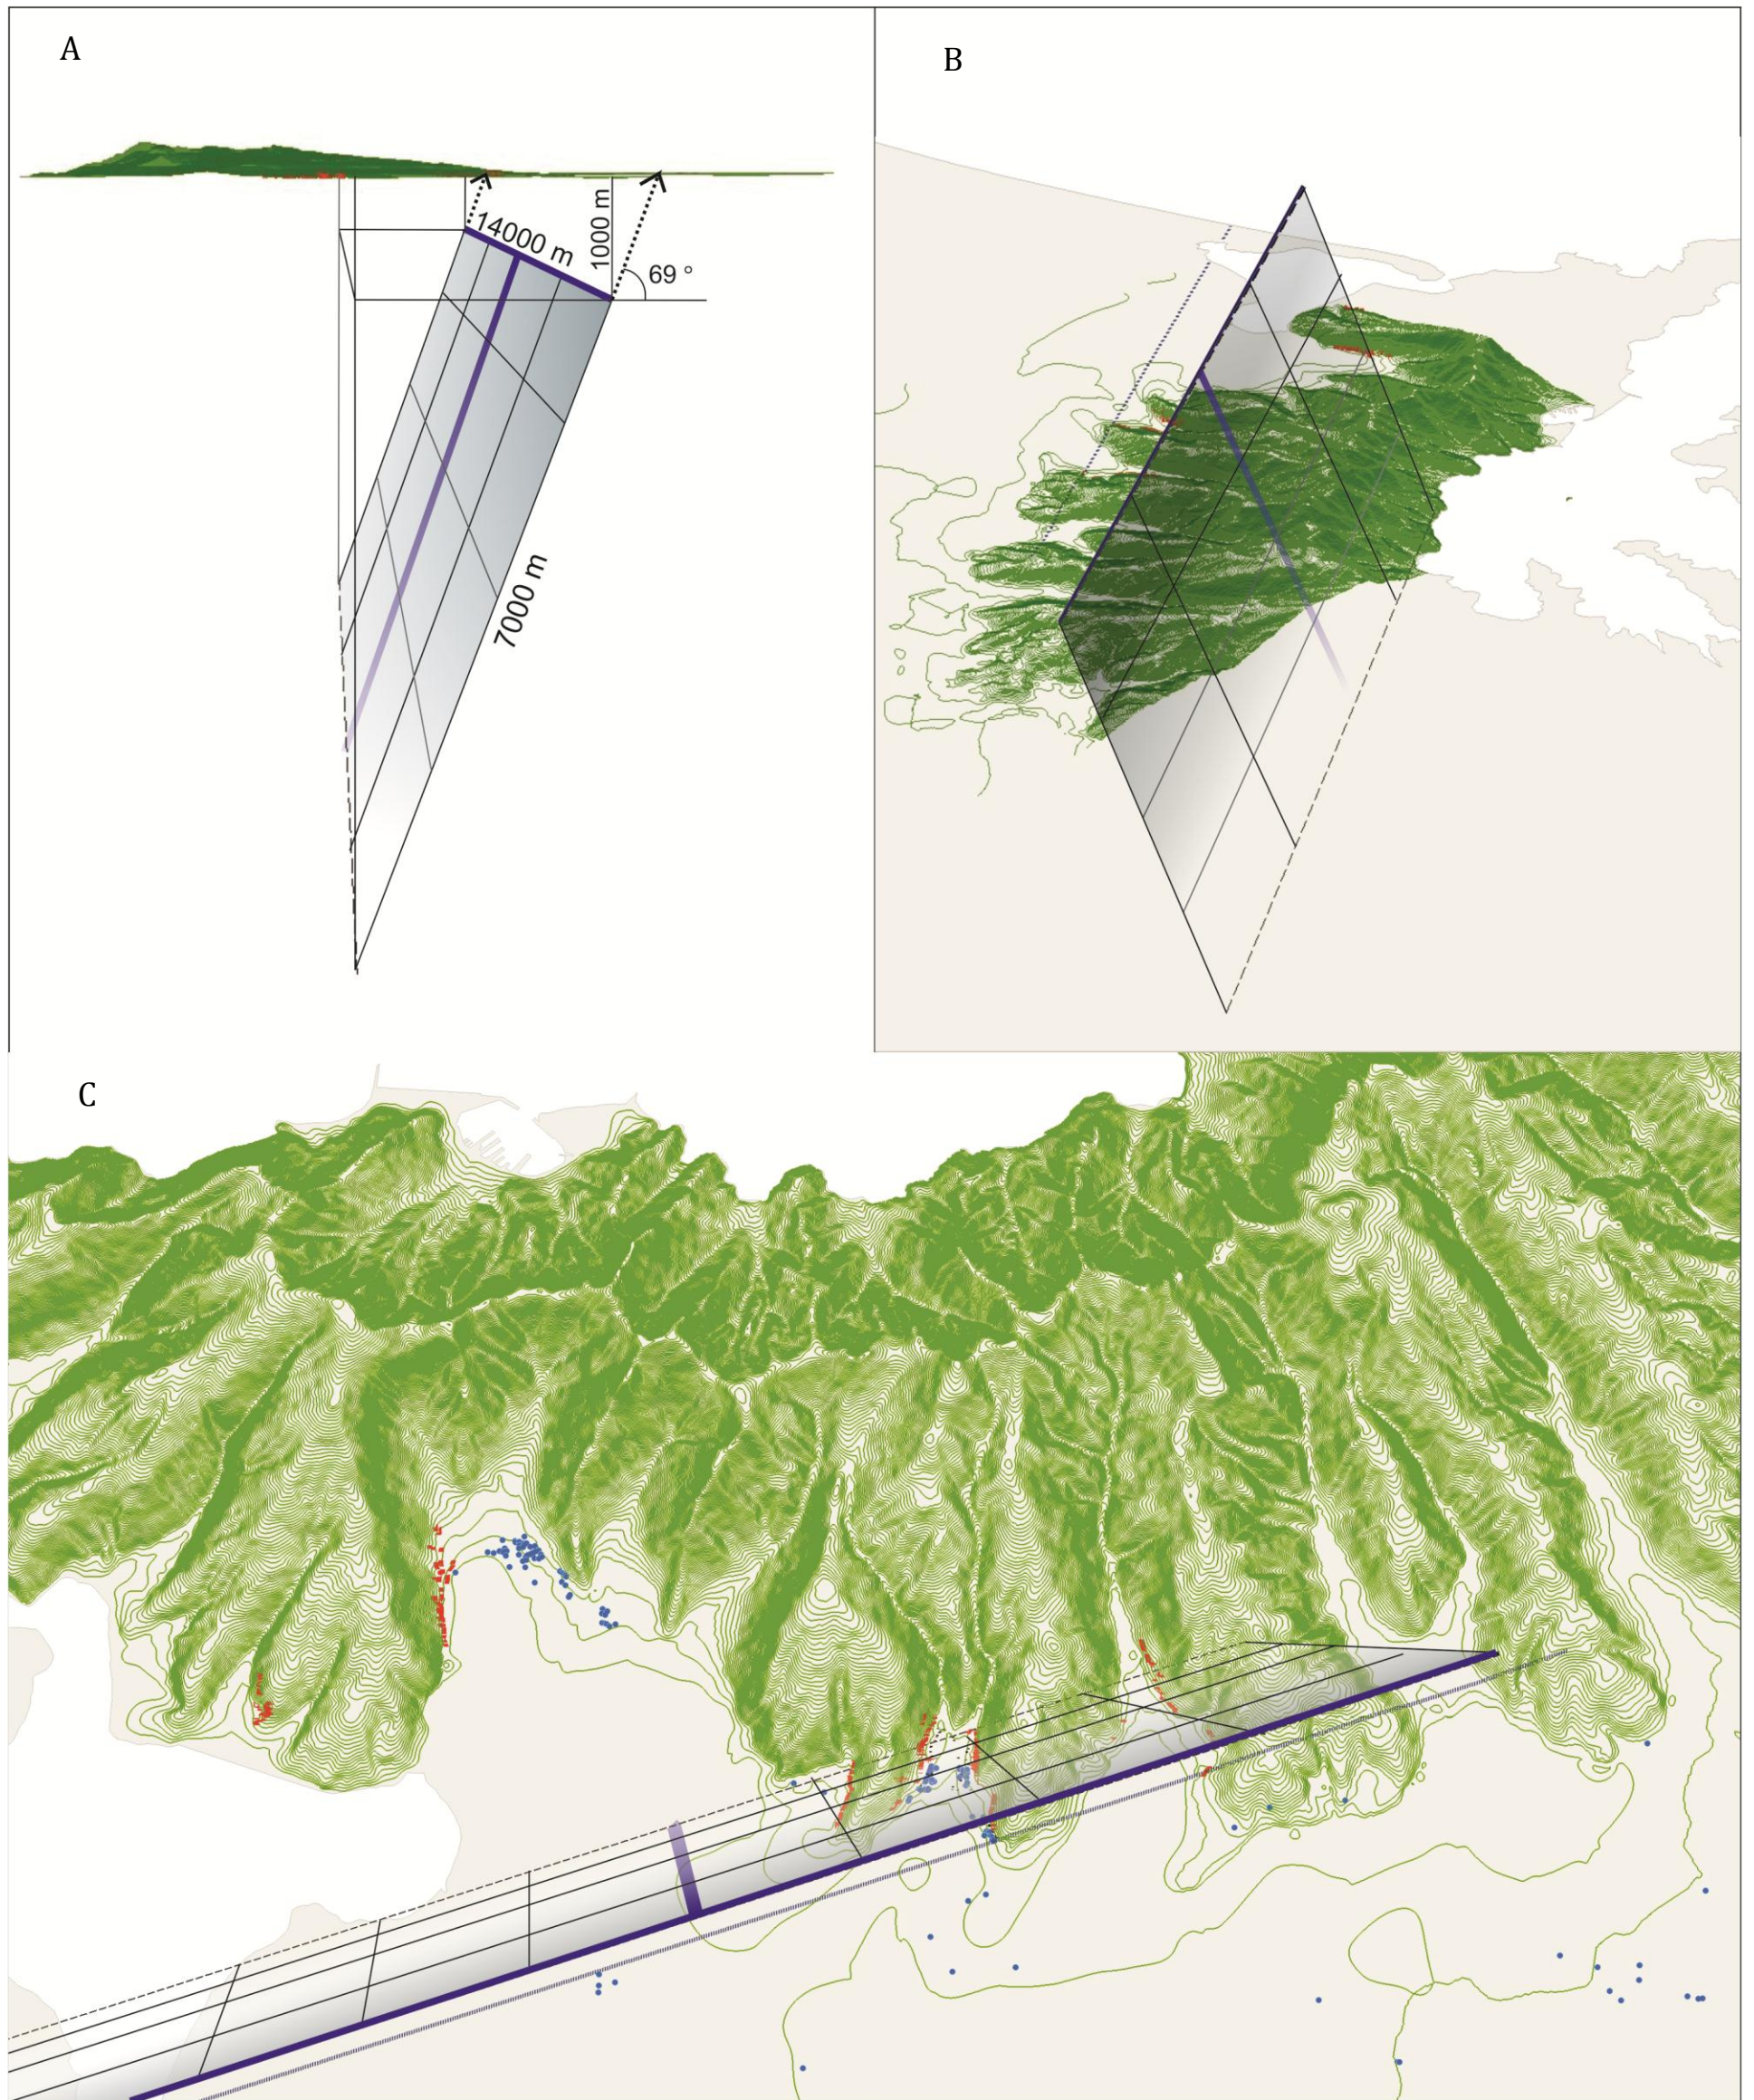
Figure 5.6 Modelled location of fault plane of the Christchurch Earthquake of 22 February 2011, based on data from Kaiser et al. (2012). Fault strike = 58°; dip = 69° SE. Model shows the top edge of the fault plane as a thick blue line at 1 km below the surface, with an approximate surface expression as a thin blue line, separate to the fault plane. Fissures are marked in red, and springs as blue dots. (A) Facing due west, looking along fault trace, below the Port Hills. (B) Facing east and looking obliquely down at fault trace. (C) Facing south and looking obliquely down fault trace.

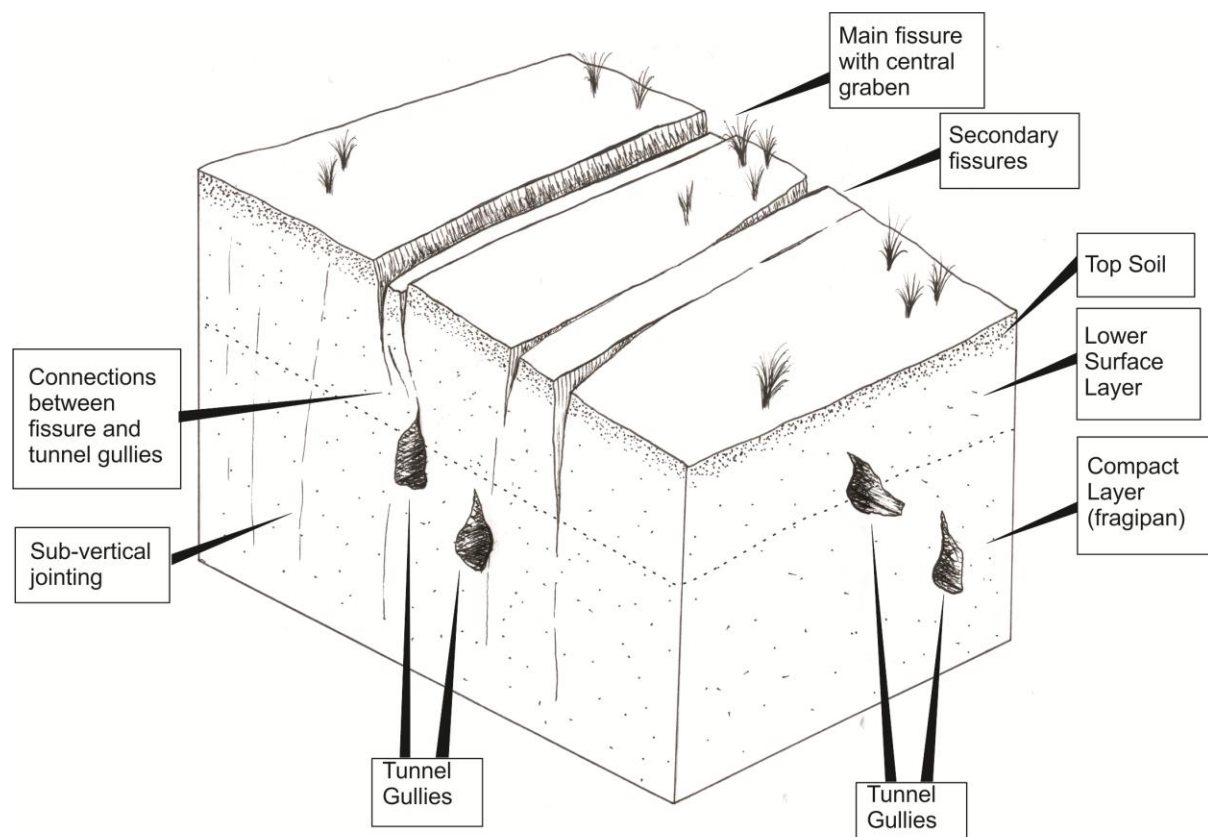
It is proposed that the sub-vertical columns inherent of the fracturing within the Port Hills loess discussed earlier in the thesis, may have split apart from each other, in a similar way to that discussed by Lutenecker and Hallberg. Figure 5.8 provides a block diagram sketch of the

possible subsurface structure of the loess based on observations made at 3 Glenview Terrace, showing sub-vertical columns within the loess splitting apart. Rather than there being a road cut to remove lateral support, as described by Lutenecker and Hallberg (1988), in the case of the Port Hills fissures, the lateral support would have been provided by sediments in the valley floors, many of which liquefied during the Christchurch Earthquake, thus effectively temporarily removing lateral support.

Figure 5.8 Schematic block diagram of fissured section of loess showing toppling within sub-vertical jointing of the loess body, and interactions of fissures with tunnel gullies. Scale: depth of land block shown approximately 2 m.
